**GROUP CHAIRMAN'S FACTUAL REPORT OF
INVESTIGATION
Onboard Image Recorder Factual Report
WPR15FA021**

Onboard Image Recorder

Group Chairman's Factual Report
By Sean Payne

Location: Ridgecrest, California
Date: October 24, 2014
Aircraft: Slingsby T-67M 260, N456FR
Operator: National Test Pilot School
NTSB Number: WPR15FA021

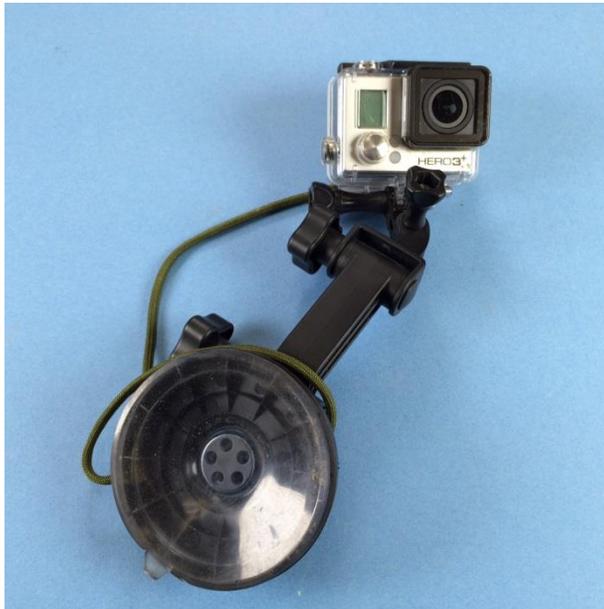
The GoPro camera arrived to the NTSB Vehicle Recorder Division in an undamaged state. The lens and rear communications port was found to have trace amounts of debris. The SanDisk SDXC memory card also arrived undamaged and was found seated in the GoPro's memory card slot inside the watertight enclosure. The memory card was read out normally on a PC using a forensic write blocker. Figure 1 shows the condition of the GoPro Hero, figure 2 shows the condition of the 64 GB SanDisk SDXC memory card.

Figure 1. The condition of the GoPro Camera.

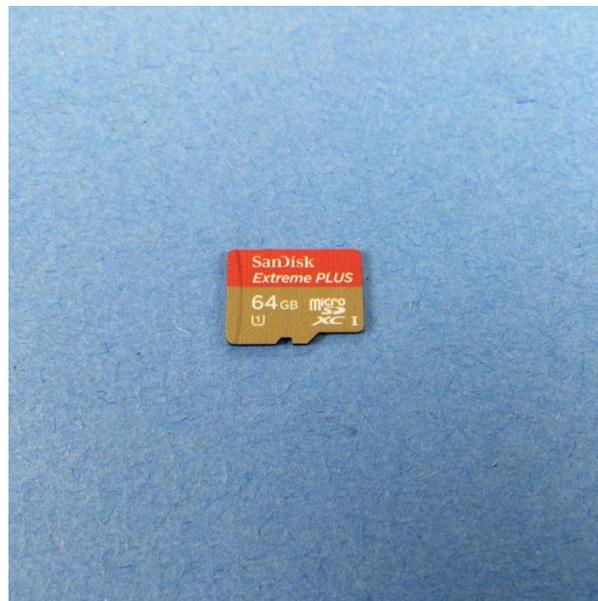
Figure 2. The condition of the micro SD card.

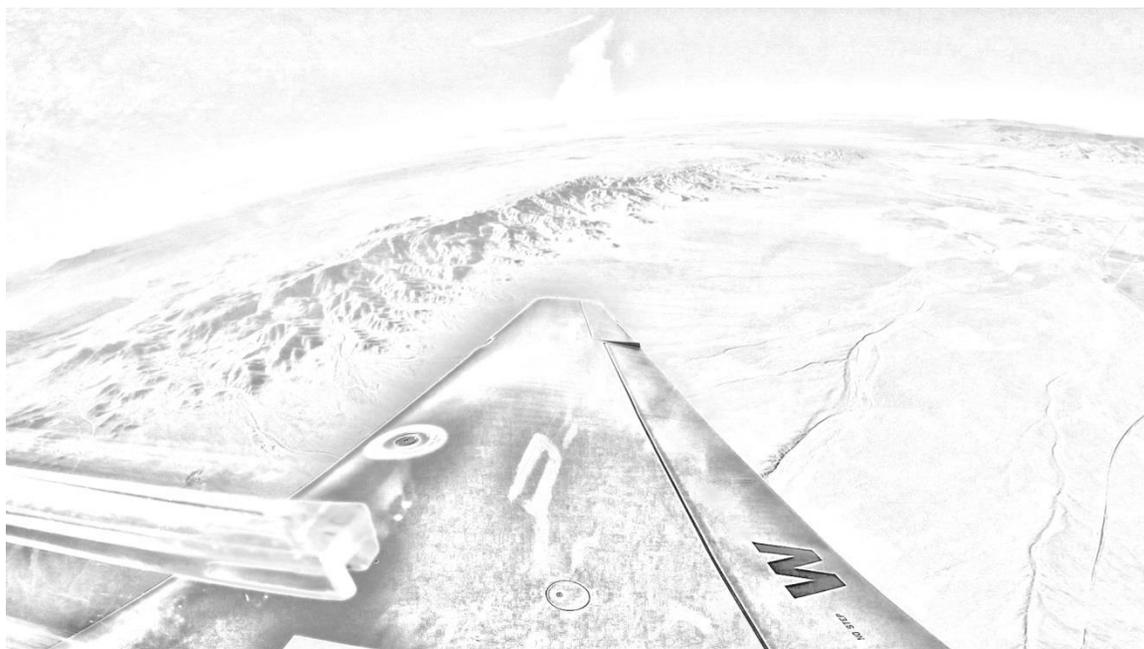
The GoPro was mounted to the right side of the aircraft's canopy using a GoPro suction cup mount. The camera provided a view of the right wing. Within the field of view, the right wing was visible from root area near the right side of the aircraft to the right wingtip. The right aileron and a large portion of the right flap were visible. The movement of the right aileron and flaps were noticeable throughout the recording. Additionally, a reflection of inside the cockpit could be seen during portions of the recording when lighting conditions were favorable. The reflection was mostly the torso of the student, in the right seat, who was wearing a green flight suit. Occasionally the instructor, in the left seat, could be seen in the reflection wearing a blue flight suit and wearing a silver jewelry band on his right wrist. At times the left seat pilot and instrument panel became distinguishable. Figure 3 shows the field of view of the rightward facing GoPro camera for most of the recording.

Figure 3: A digital illustration of the field of view of the canopy mounted GoPro Hero 3+ Black.
