>>> Service Letter

Number: L93-02 H

Subject: Overhaul and repair for SA10200-A1 Cylinder Stud Assy.

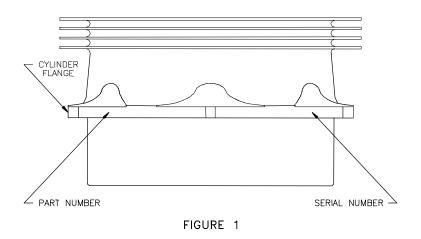
This service letter covers specific differences between a Superior Air Parts, Inc. SA10200 series Millennium Cylinder®, and the original equipment manufacturer's cylinder, as it pertains to repair and overhaul. If a specific procedure is not addressed in this Service Letter, the applicable procedure in the original equipment manufacturer's current overhaul manual applies. The cylinders are identified by part number and serial number on the cylinder flange, as shown in Figure 1.

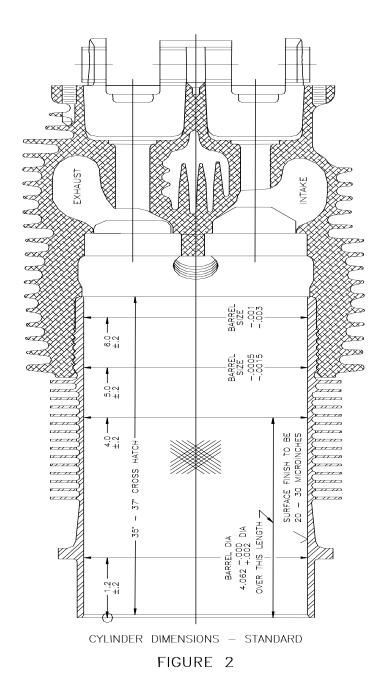
The Millennium Cylinder® barrels are manufactured from AMS 6382 steel and through-hardened with a choke bore, which should be maintained during any boring or honing operation. See Figure 2 for standard cylinder dimensions and finish specifications.

Any time a cylinder is removed, the diameter and out-of-round condition should be checked as well as cylinder scoring, galling, low spots and ring step. Inspection results should be compared to the dimensions in Figure 2 and in the original equipment manufactures current overhaul manual. Worn through-hardened steel cylinders can be oversized to .015 or chrome plated back to standard dimensions. Piston rings listed for use in steel cylinder barrels must be used in through-hardened steel barrels.

Millennium Cylinder® may have the cylinder bore returned to new limits by having the cylinder barrel replaced by a Superior Air Parts licensed FAA Repair Station. The old worn barrel is removed and a new Superior Air Parts FAA-PMA Millennium Cylinder® barrel (the same high quality barrel used in new Millennium Cylinder® assemblies) is installed. This procedure returns the cylinder bore to the new steel limits shown in Figure 2, as well as, assuring that other critical dimensions, such as, compression height and cylinder barrel flange hole alignment, are returned to new limits. Superior Air Parts Customer Service may be contacted for approved sources of this repair.
